2 Type of change

0909 Multiple IEC Appliance Outlets F							
Release date:	Released by:						
24.5.2011	SHÖ					1 von 2

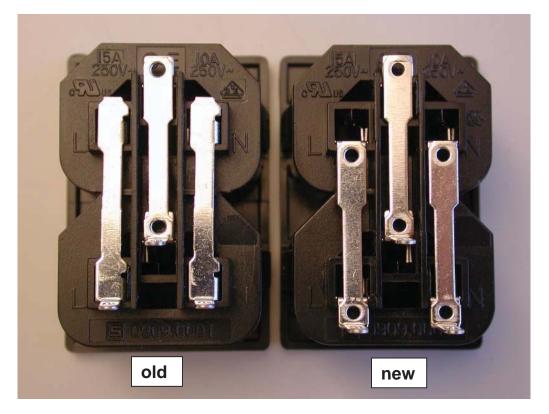
The old version had only the earth bar riveted to the outlet contacts - L/N bars and contacts were made of one piece. The new version has L/N/E riveted. (The holes are the riveting joints)

Position of solder terminals of L&N are moved approx 5mm towards the border of the connector.
